SUBJECT: McAuliffe ES - IAQ - Air Test Results - Room A-116

Re: Limited Mold Assessment Services
McAuliffe Elementary School
Room A-116
2300 Briarhill Boulevard
Highland Village, Texas
LISD PO No. 91718928-00
Apex Project No. 725010727049

IAQ Mold Report

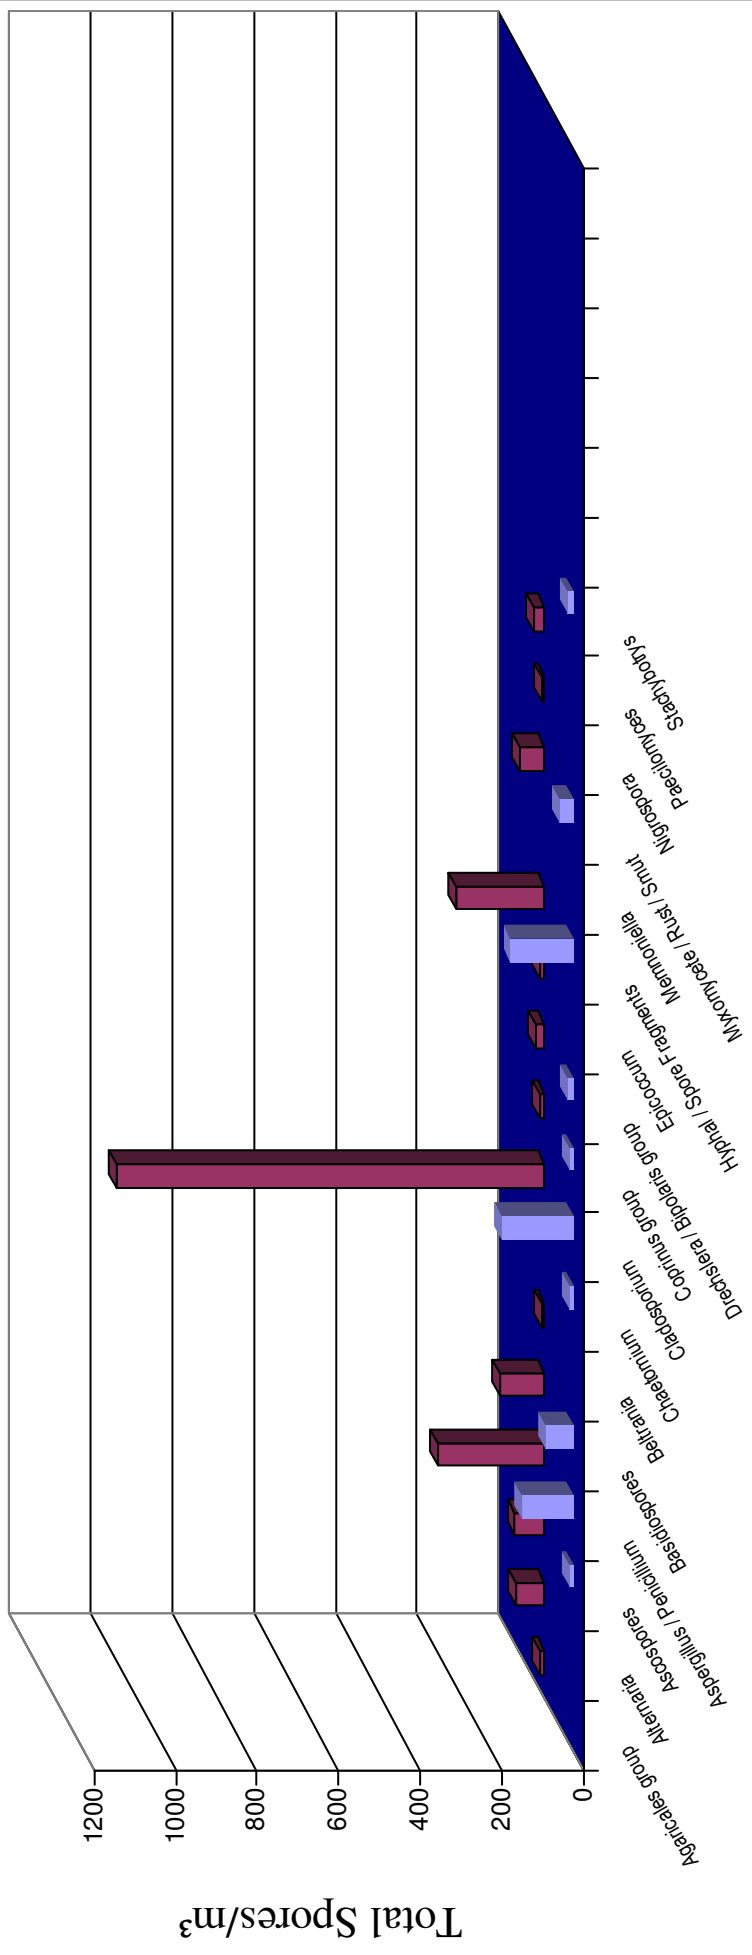
Room A - 116

Air testing performed using spore traps indicated that total airborne mold spores in the classroom was lower as compared to those measured outside of the building at the time the sampling was performed. The total fungal spore concentration within the investigation area was reported as 600 counts/m³, while the exterior level ranged from 1,607 to 2,189 counts/m³.

Two (2) types of mold were identified at a higher concentration within the investigation area as compared to the sample collected from the exterior of the building. Air sample(s) collected within the classroom reported *Stachybotrys* was reported as 13 counts/m³ and *Chaetomium* was reported as 7 counts/m³ while no exterior levels were reported.

■ Sample ■ Average Reference 1 □ Average Reference 2

Average Reference 1 = Exterior, North, Exterior, Northeast

Based on Apex’s limited assessment, Apex recommends that the water damaged areas be replaced.
